Manhole Inspection Summary

Manhole # S15WW_001MH

Insp Date: **4/3/07 9:31 AM**

Location Address: **3400 REISTERSTOWN RD** Cross Street: **PARK HEIGHTS AVE**

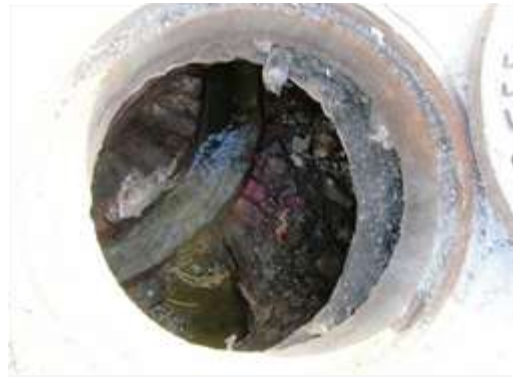
Top View

Evidence of surcharge - Bench debris.

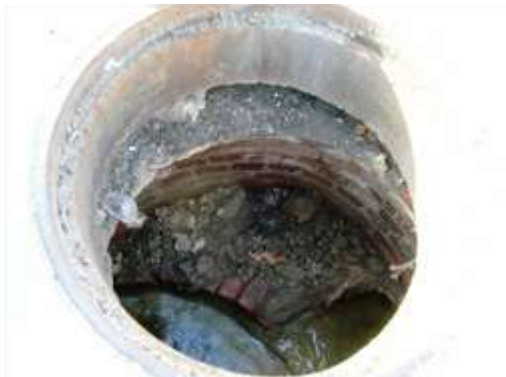
Defect

Frame leaks. Frame offset. Adjustment and Corbel deterioration and infiltration. Barrel infiltration - other side.

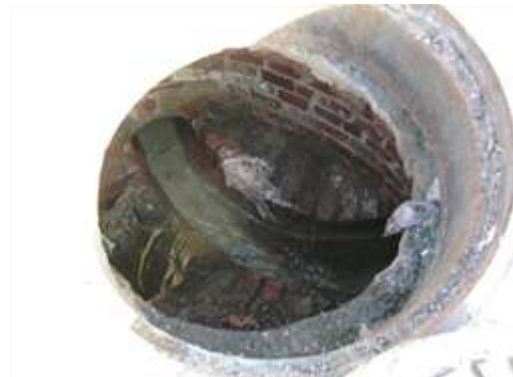
Defect

Frame leaks. Frame offset. Adjustment and Corbel deterioration and infiltration. Barrel infiltration.

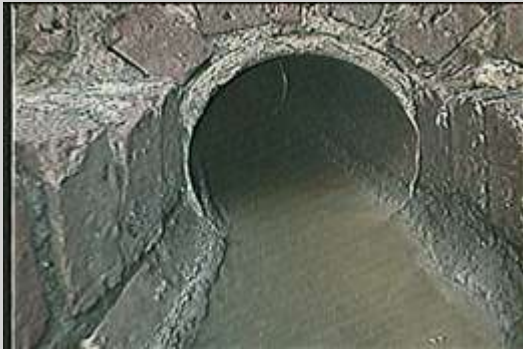
8 in. Circular Gravity Sewer Pipe Out @ 12 O'Clock

Infiltration: **Evidence** Pipe Seal Cond: **Cracked**

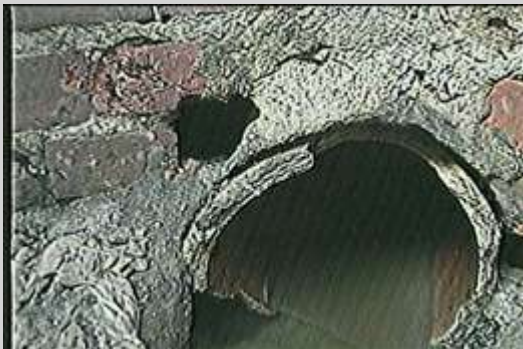
8 in. Circular Gravity Sewer Pipe In @ 5 O'Clock

Barrel deterioration and infiltration. Channel deterioration.

Infiltration: **Evidence** Pipe Seal Cond: **Broken**

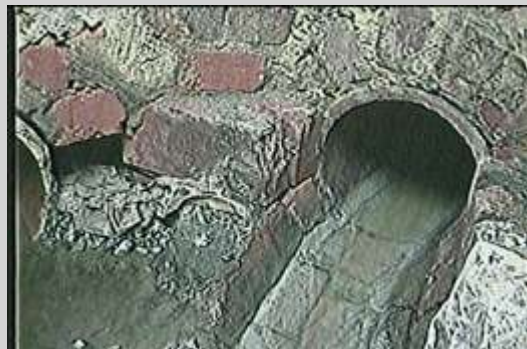
Pipe In @ 8 O'Clock

Barrel deterioration and infiltration. Channel deterioration.

Infiltration: **Evidence** Pipe Seal Cond: **Unknown**
